Conditions Report

**Oregon Water Tower
Pump Building**

**Mead
& Hunt**

Date 12.16.13

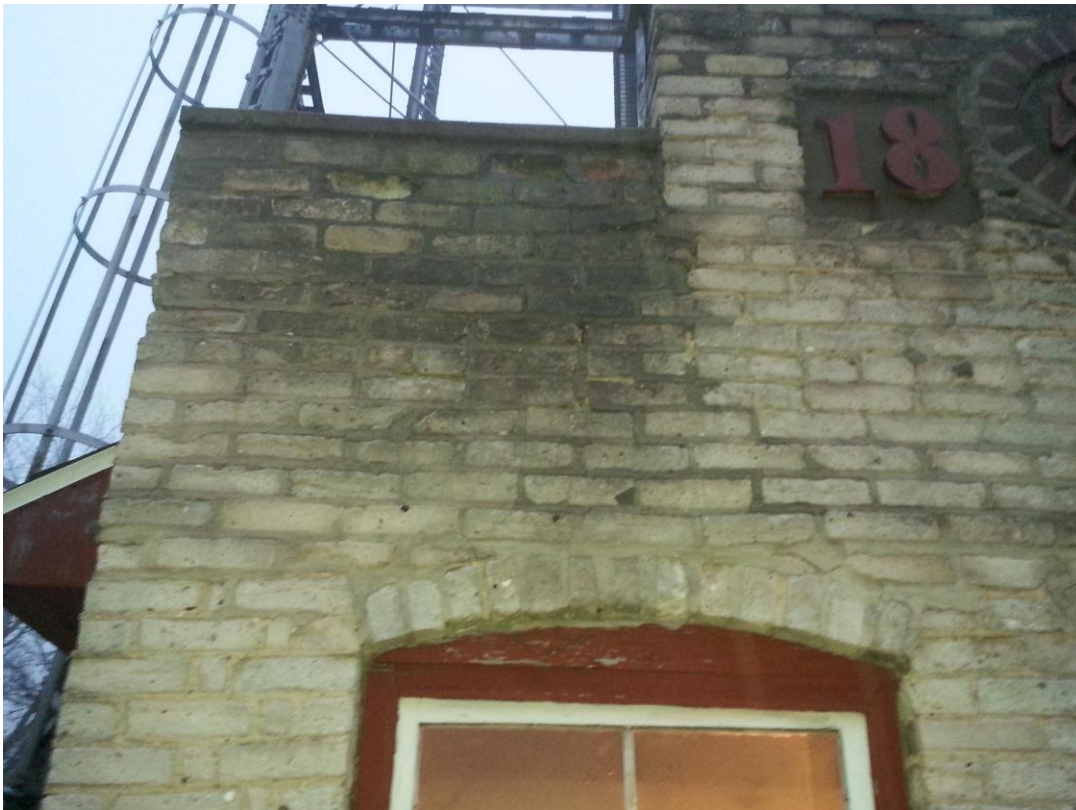
Brick needs to be repointed and cleaned.

- b. Repointing of the brick is critical to keeping water out of the building. The current mortar is in failure mode allowing water to get inside the wall and further damage the building.
