# Conditions Report

**Oregon Water Tower  
Pump Building**

**Mead  
& Hunt**

Date 12.16.13

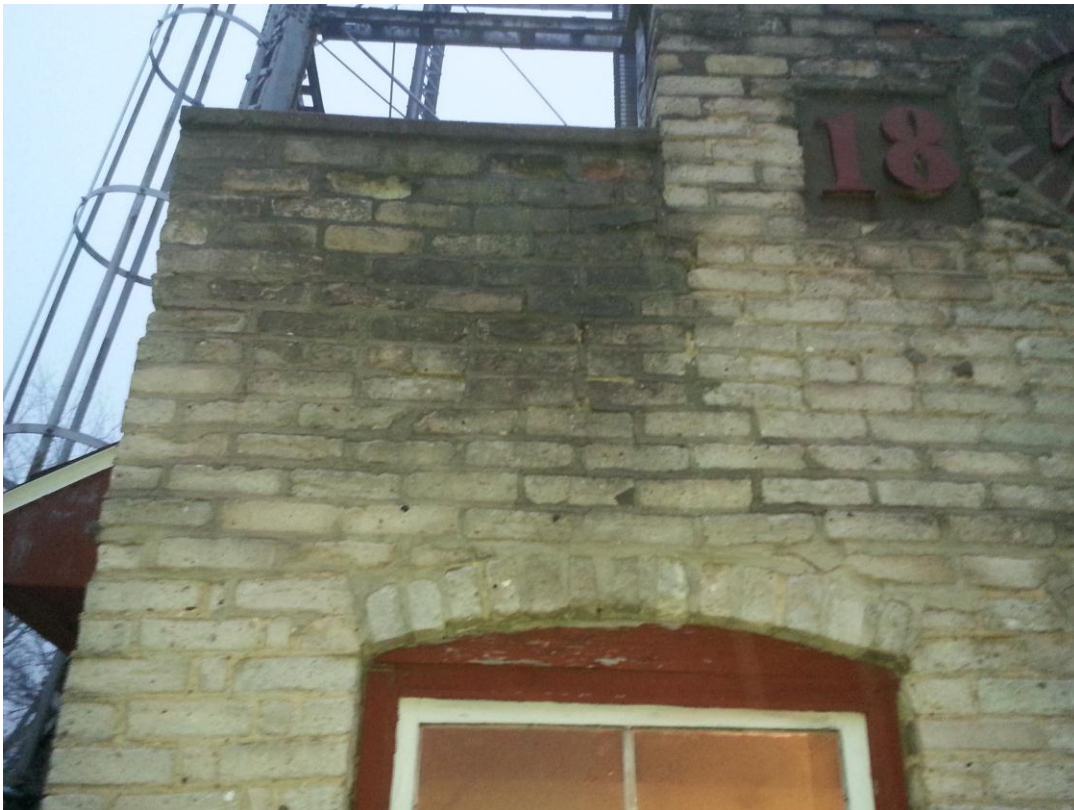
Brick needs to be repointed and cleaned.

- b. Repointing of the brick is critical to keeping water out of the building. The current mortar is in failure mode allowing water to get inside the wall and further damage the building.

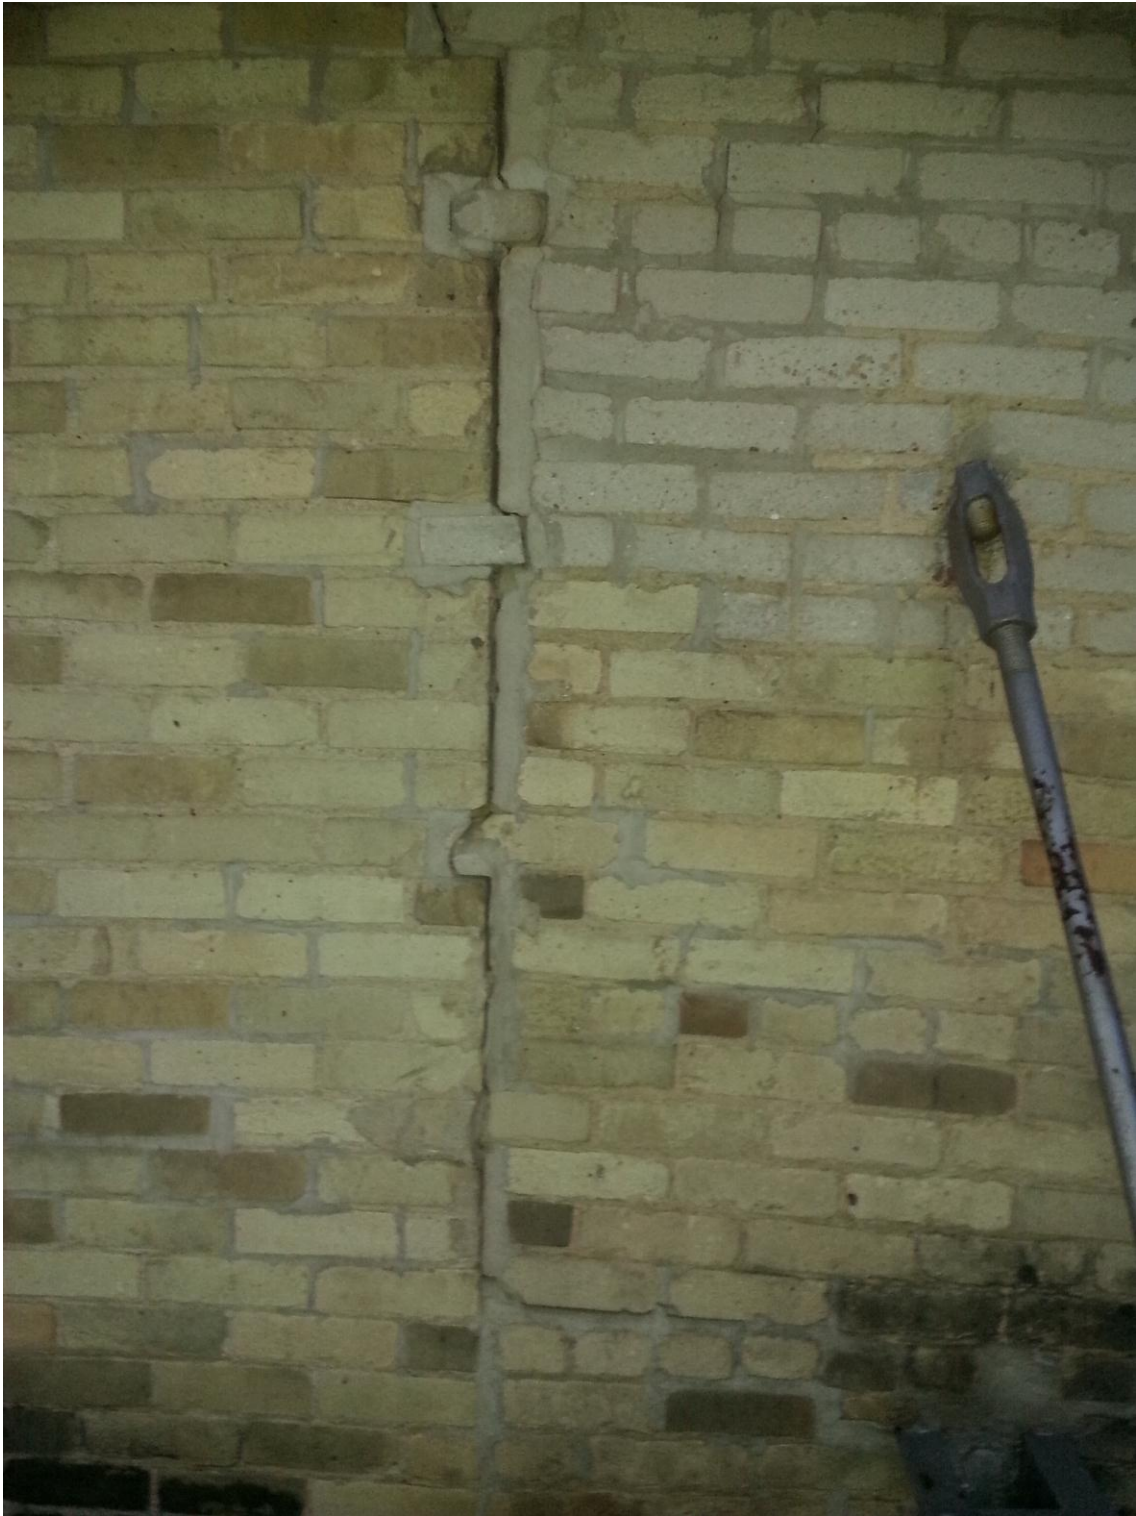
East side exterior wall crack that has been repaired and continue to move in a downward direction. The crack is at least ¼" at the top and the interior space could be seen from the outside.

- a. The foundation system for the front of the building needs to be examined in great detail and a repair/stabilization program should be implemented. The building has been

moving and continues to move as evident in the wall cracks and the slab failure at the front door. Patching wall/brick cracks will not solve the problem, in fact if the repairs/stabilization are not implemented a major failure to the front of the building is inevitable.

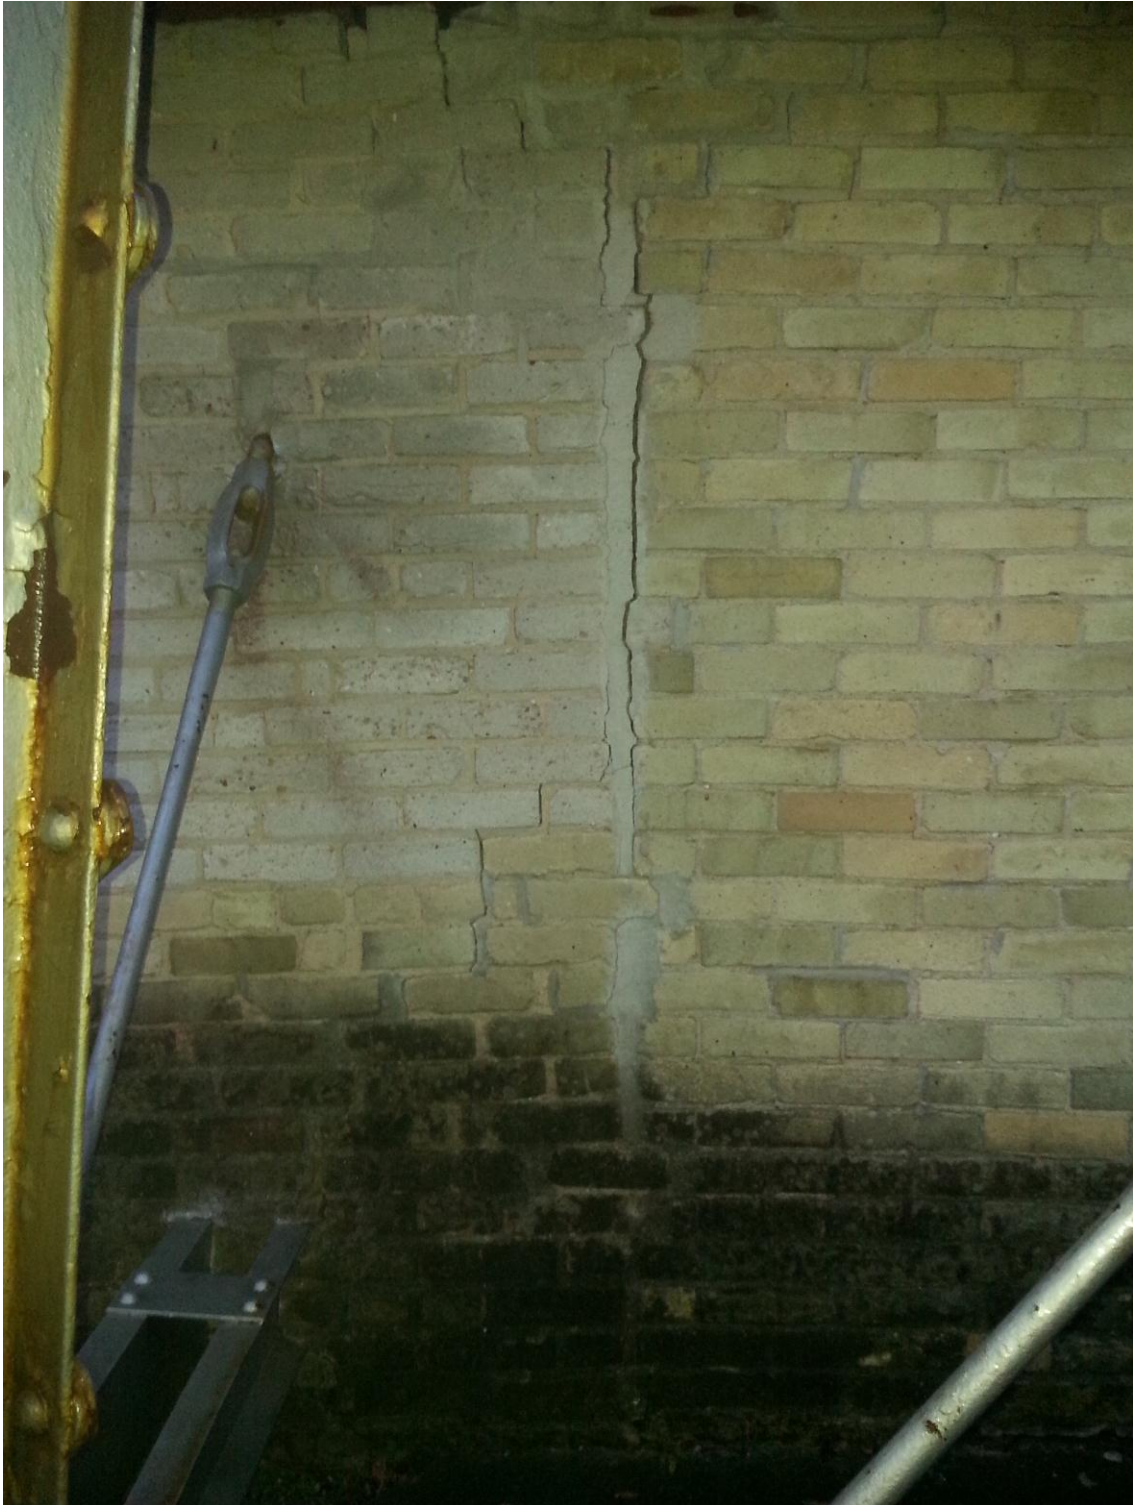
West side exterior wall crack that has been repaired and continue to move in a downward direction.

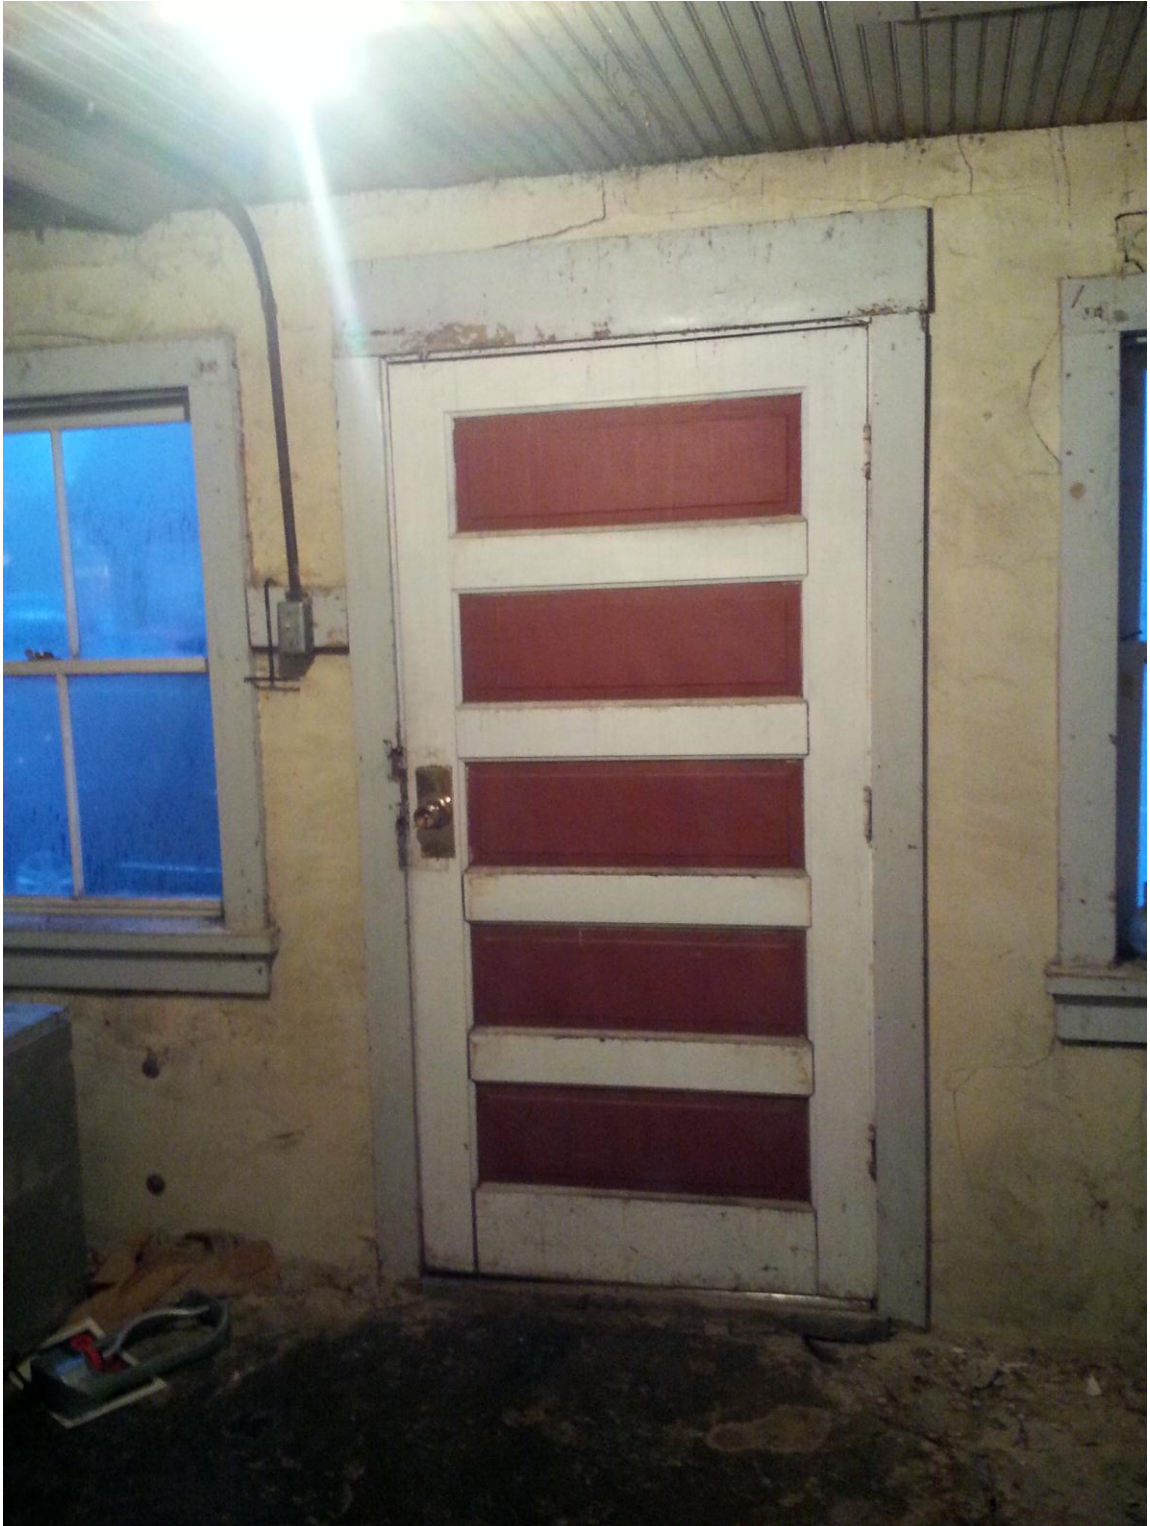
The floor at the door is broken in a number of places indicating foundation movement.

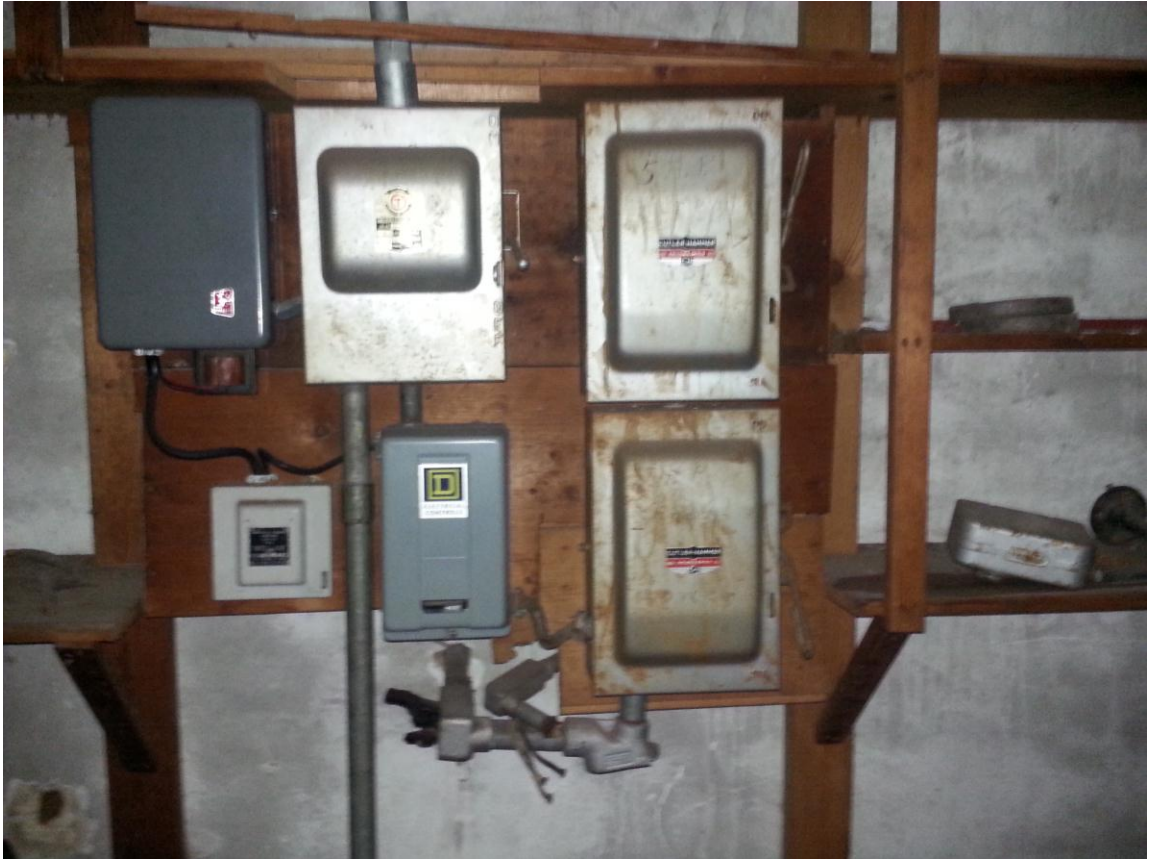
- f. The electrical system is a combination of several eras, with some of the systems looking as original and some looking more modern. Conduit to fixtures and outlets was surface mounted with heavy rust.

Existing electrical system should be reviewed by an electrical engineer for compliance with current codes if the pump house is to be used for a public function.

- d. The electrical systems need to be reviewed by a qualified electrical engineer. It is highly likely that they will need to be replaced to meet current code if the space is used for a visitor center.
